== USS VICKSBURG (CG-69) ==
SEMAT II SHELL CONDITION ASSESSMENT
SURVEY
INTERIOR AREAS
10/22/01 TO 11/02/01

PREPARED BY
SUPERVISOR OF SHIPBUILDING CONVERSION
AND
REPAIR
PORTSMOUTH, VIRGINIA
11/09/01

USS VICKSBURG (CG-69)
SHELL CONDITION ASSESSMENT SURVEY, INTERIOR AREAS.

A SEMAT II UNDERWATER HULL AND SUPPORTING STRUCTURE SURVEY OF INTERIOR AREAS WAS CONDUCTED ON BOARD **USS VICKSBURG (CG-69)** FROM 10/22/01 TO 11/02/01 AT MAYPORT NAVAL STATION, JACKSONVILLE FLORIDA.

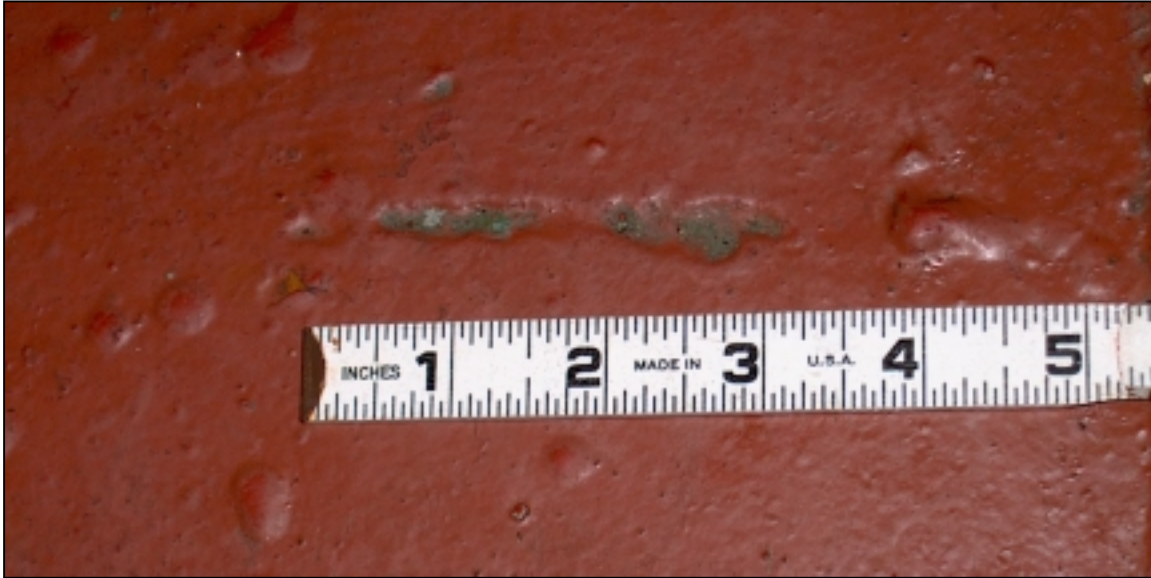
STBD SIDE BETWEEN WEB FRAMES (509-512) AND STRINGERS (7-8)
PIT IS .188 DEEP WHICH IS ABOVE THE 25% WASTAGE ALLOWANCE.
CLAD WELDING IS RECOMMENDED

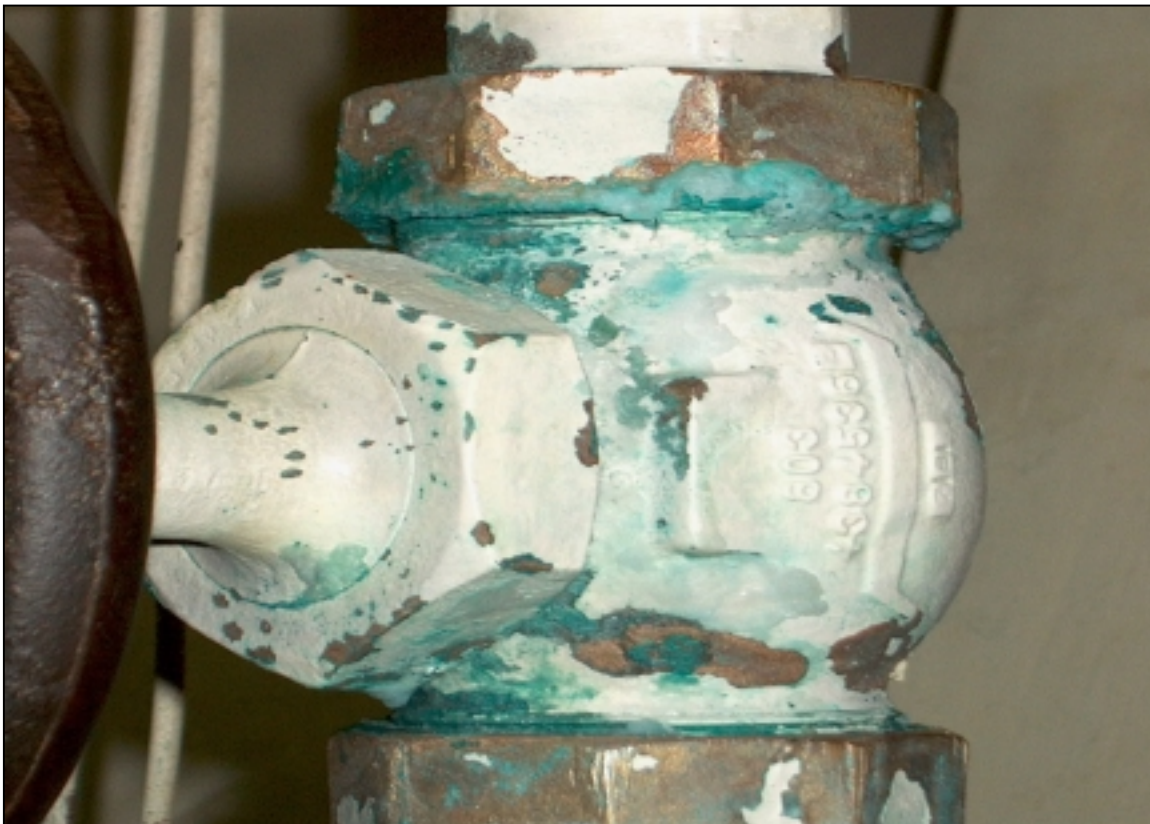
SALT WATER EDUCTOR VALVE (3-510-1) IS LEAKING
ROOT CAUSE FOR CORROSION

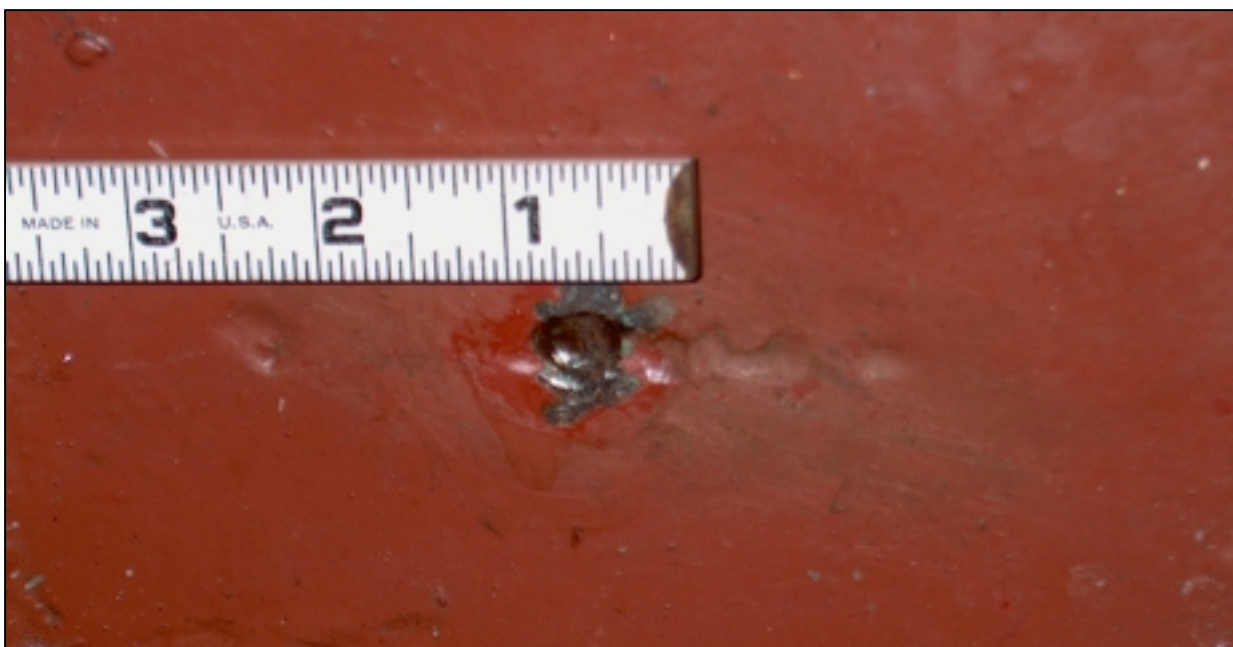
</div> <div>.750 PLATE MINIMUM .562</div>
	.490△	.461△	.485△	.498△	.497△	.495△	
						.312* DEEP PITTING	
	.760△	.757△	.765△	.760△	.762△	.762△	
	*.572						
	.761△	.760△	.761△	.765△	.765△	.762△	
STRINGER 7 (24 X 8 T-BEAM)							
J. LaROCK / T. ILGENFRITZ QED SYSTEMS INC. 10/22/2001

STBD SIDE, SHELL PLATE BETWEEN WEB FRAMES (512-515), AND STRINGERS (7-8)
 PIT IS .188 DEEP WHICH IS BELOW THE 25% WASTAGE ALLOWANCE.

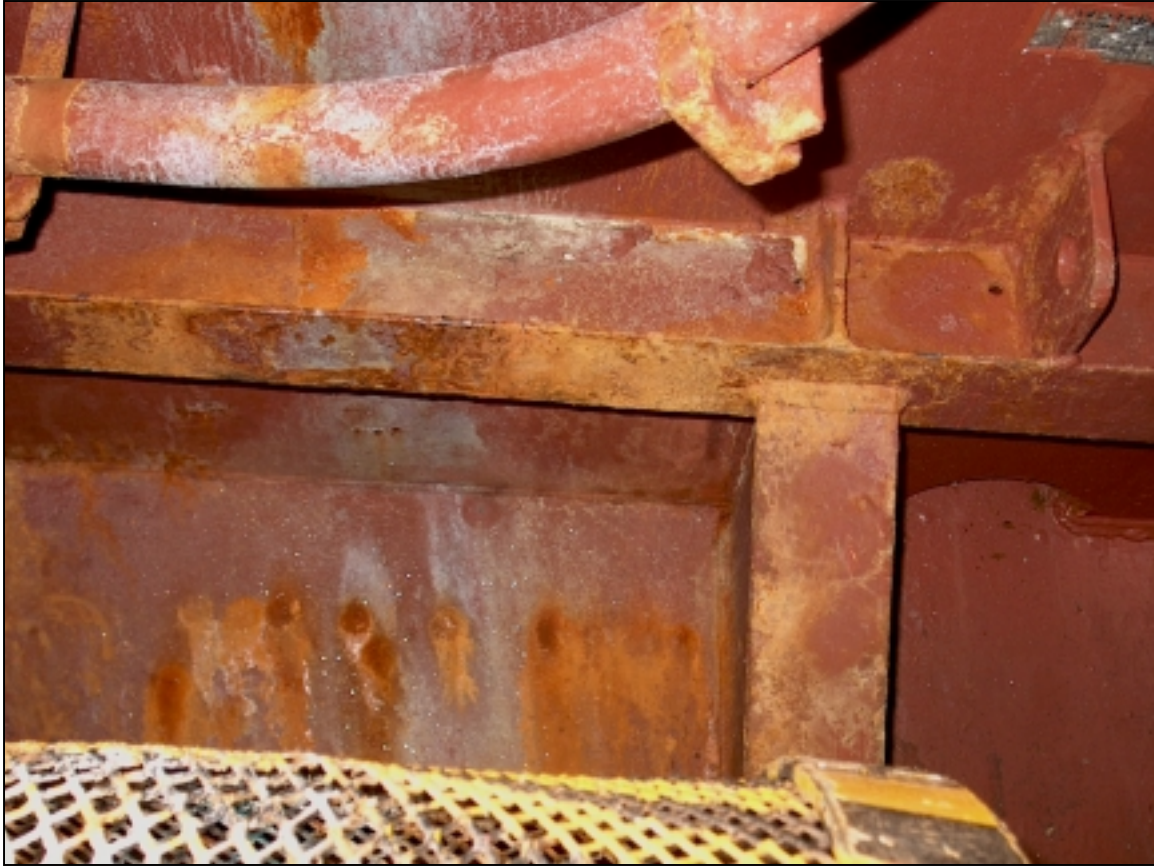
DISCREPANCY DESCRIPTION: PER SEMAT II UNDERWATER HULL ASSESSMENT: (6-346-0-E) SHAFT ALLEY/SEWAGE PLANT NO.3					
FLANGE ON FIRST STIFFNER OFF DECK ON SWASH BHD OUTBOARD OF STBD SHAFT IS CORRODED APPROX 10 FT AFT OF BHD (346). THERE IS CORROSION ON BOTH PORT AND STBD SWASH BHDS AND AROUND THE BALLAST BLOCKS. APPROX 200 SF.					
RECOMMENDED REPAIRS: RECOMMEND REPAIR ACTIVITY CUT OUT AND REPLACE APPROXIMATELY 1 LF OF STIFFNER FLANGE REMOVE BALLAST CLEAN ENTIRE AREA TO BARE METAL, PRESERVE AND PAINT TO MATCH, REPLACE BALLAST.					
.					
SSPORT C221 POC: B. WILLIAMS (757) 396-4001 EXT 2130, TPOC: M. MELVIN					
CSMP SUMMARY: STIFFNER FLANGE IS CORRODED ON STBD SIDE/MODERATE PAINT SEPARATION PORT / STBD SIDES				TEST# MRC 1102/1	
ROOT CAUSE/AMPLIFICATION: H1				STEP# 1,2,3,4 & 5	
SYSTEM LEVEL IMPACT:					
PART NO.	NOMEMCLATURE		QTY	NSN	COST
1					
2					
3					
4					
5					
6					
FIRST CONTACT BREKKE	RATE HT1	SECOND CONTACT CARL	RATE HT2	PHONE

CORROSION ON SWASH BHD OUTBOARD OF PORT SHAFT.

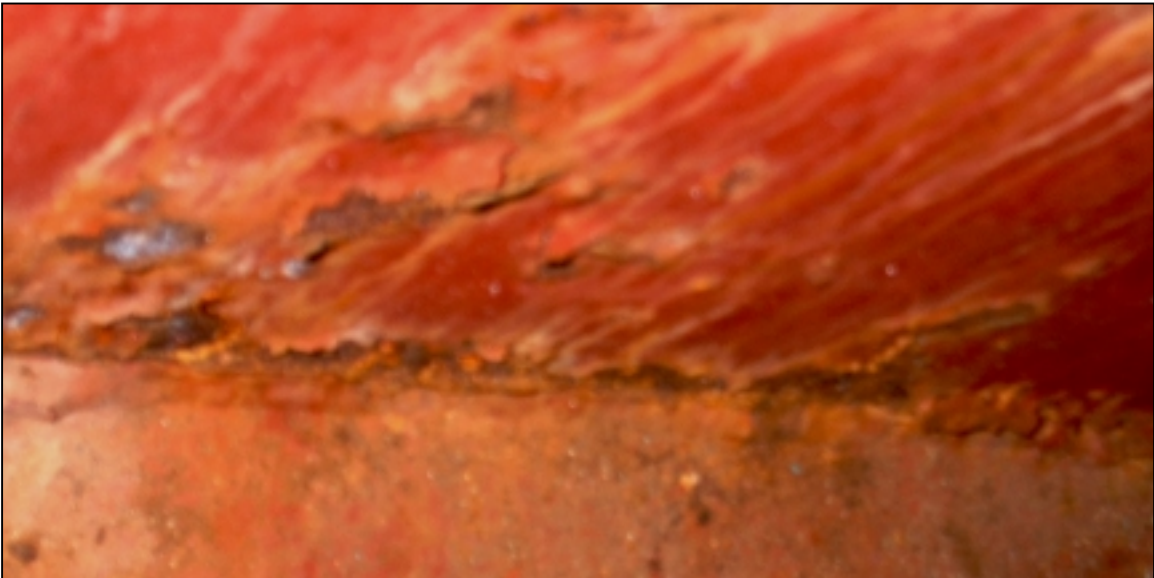
CORROSION ON STIFFNER OUTBOARD OF SWASH BULKHEAD

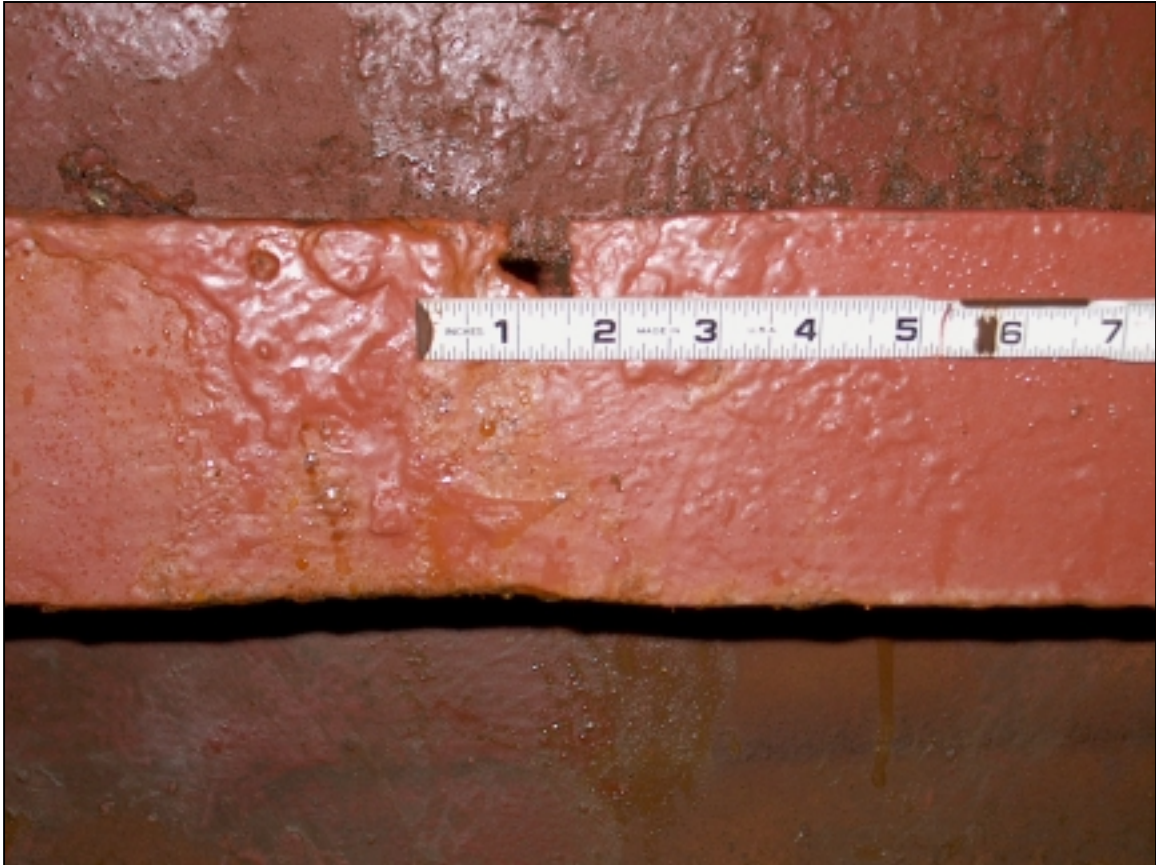
DISCREPANCY DESCRIPTION: PER SEMAT II UNDERWATER HULL ASSESSMENT: PORT SIDE (5-300-0-E) MER 2					
BETWEEN BHD (300) AND WF (308) FIRST STRINGER UP FROM MARGIN PLATE, FLANGE IS CORRODED APPROXIMATELY 6 FT					
FWD OF BHD (300). 4 TH STRINGER UP FROM MARGIN PLATE IS THINNING AT THE WEEP HOLE, APPROX 3 FT AFT OF BHD

PORT SIDE, CORRODED STRINGER FLANGE

(300). BILGE AREA IS FULL OF WATER. MILD CORROSION AND PAINT SEPARATION, SEE ATTACHED DRAWING FOR U/T INFO.					
RECOMMENDED REPAIRS: RECOMMEND REPAIR ACTIVITY REMOVE APPROX 6 LF OF FLANGE ON 1ST STRINGER REPLACE WITH 4 X .250 MILD STEEL FLAT BAR. REMOVE APPROX 2 SF OF WEB ON THE 4TH STRINGER AT THE TRANSVERSE WELD SEAM REPLACE WITH 10 X .187 MILD STEEL FLAT BAR. CLEAN ENTIRE AREA TO BARE METAL PRESERVE, PRIME AND PAINT					
SSPORT C221 POC: B. WILLIAMS (757) 396-4001 EXT 2130, TPOC: M. MELVIN					
CSMP SUMMARY: CORRODED STRINGERS				TEST# MRC 1102/1	
ROOT CAUSE/AMPLIFICATION: H1				STEP# 1,2,3,4 & 5	
SYSTEM LEVEL IMPACT:					
PART NO.	NOMEMCLATURE		QTY	NSN	COST
1					
2					
3					
4					
5					
6					
FIRST CONTACT BREKKE	RATE HT1	SECOND CONTACT CARL	RATE HT2	PHONE	
ASSESSOR / ACT / TECH ID# J. LaROCK/ T. ILGENFRITZ			QED SYSTEMS INC.	TD	LOGISTICIAN
			TL	TSP

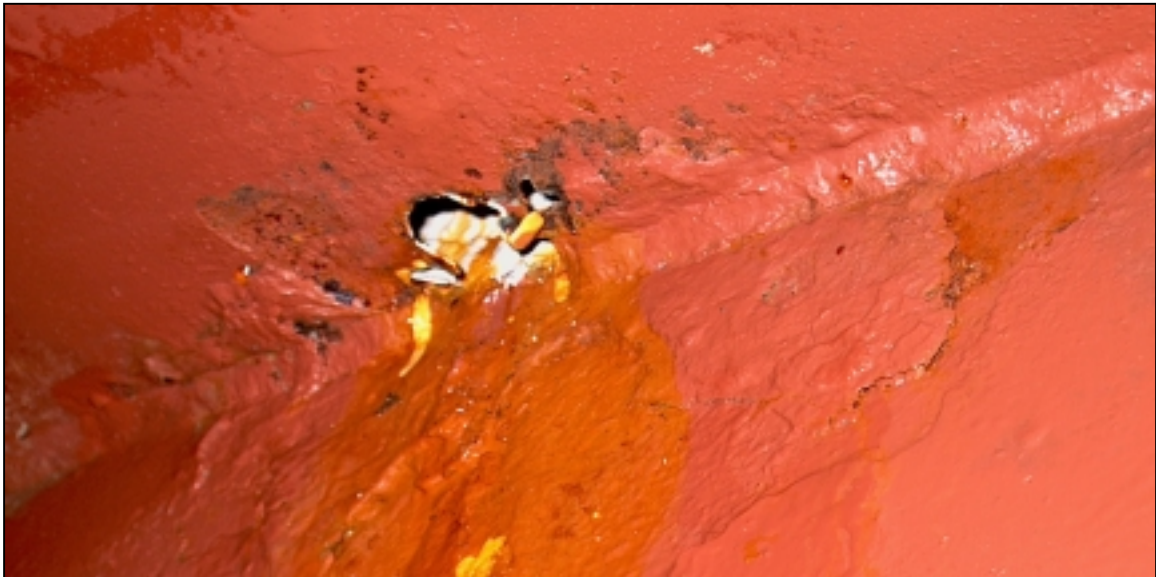
WEEP HOLE AT TRANSVERSE WELD SEAM APPROXIMATELY 3' AFT OF BHD (300)

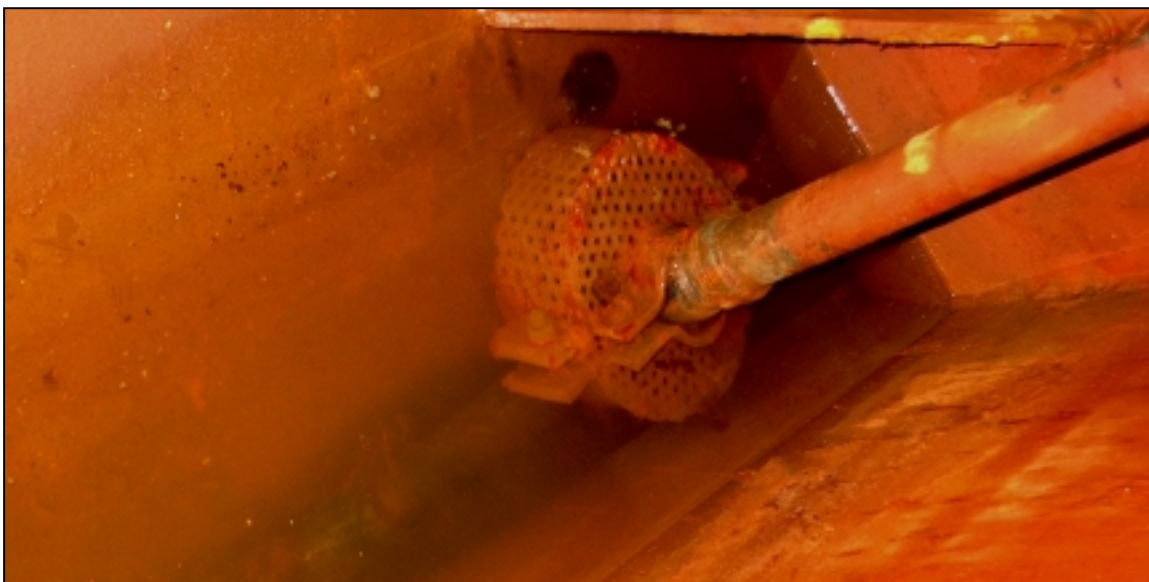
BILGE POCKET AFT OF BHD (300) AREA RECOMMENDED FOR PRESERVATION

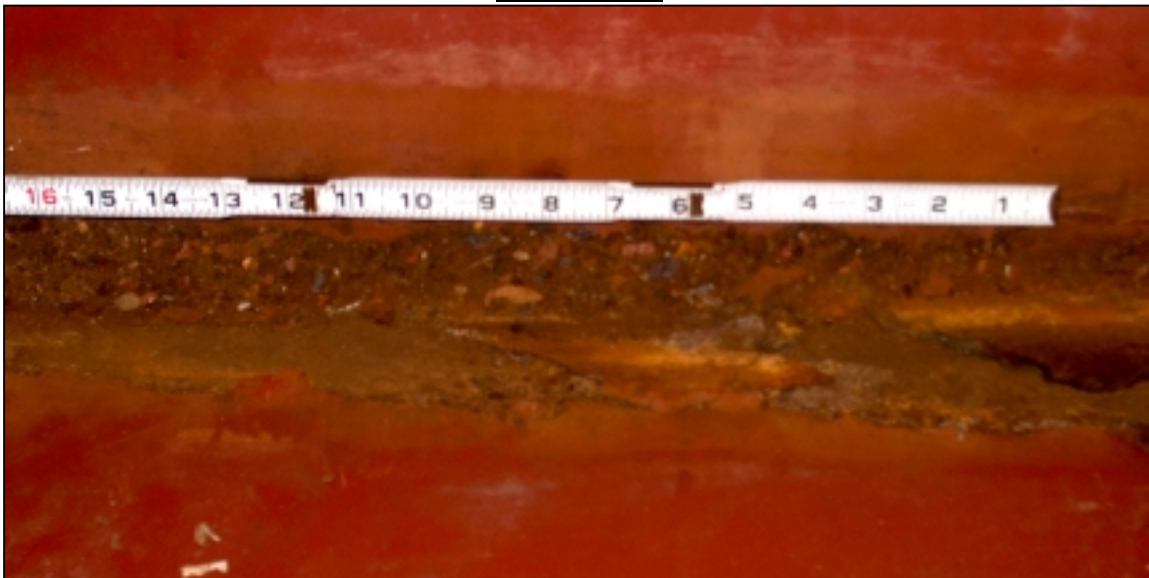
STBD SIDE BETWEEN WEB FRAMES (316-320) WHERE STRINGER MEETS SHELL PLATE
SOME THINNING WAS NOTED SEE DRAWINGS FOR U/T READINGS

RECOMMENDED REPAIRS:					
RECOMMEND SHIP'S FORCE CLEAN AREA TO BARE METAL, PRESERVE, PRIME AND PAINT.					
SSPORT C221 POC: B. WILLIAMS (757) 396-4001 EXT 2186, TPOC: M. MELVIN					
CSMP SUMMARY:				TEST#	
STIFFNER AND SHELL HAVE MILD THINNING AND CORROSION				MRC 1102/1	
ROOT CAUSE/AMPLIFICATION:				STEP#	
H1				1,2,3,4 & 5	
SYSTEM LEVEL IMPACT:					
PART NO.	NOMENCLATURE			QTY	COST
1					
2					
3					
4					
5					
6					
FIRST CONTACT		RATE	SECOND CONTACT		PHONE
BREKKE		HT1	CARL		
ASSESSOR / ACT / TECH ID#			TD	LOGISTICIAN	TSP

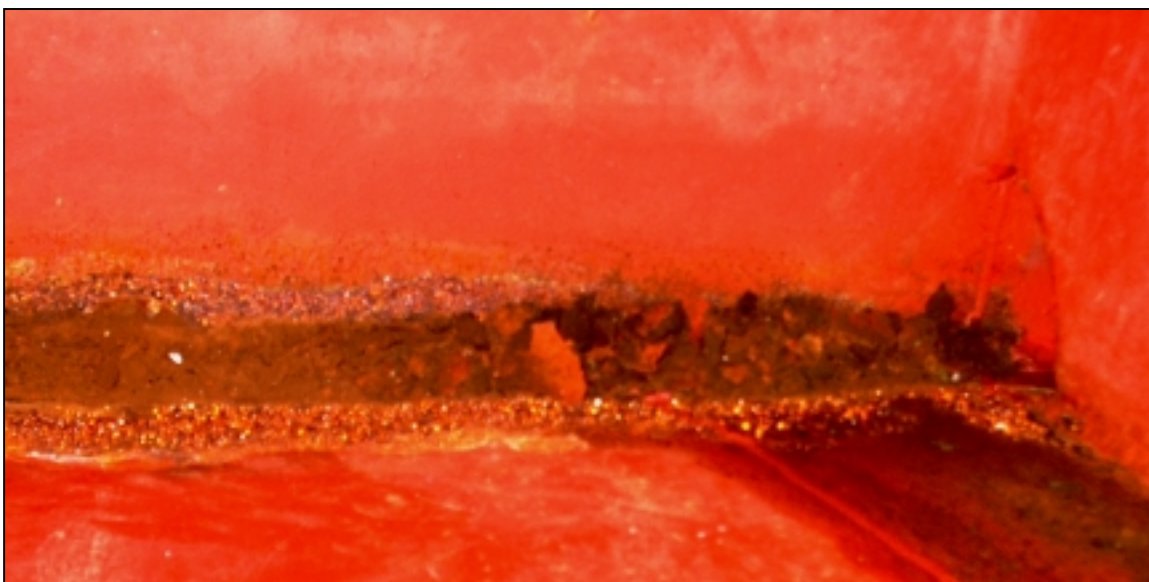
SHELL AND WEB BETWEEN WEB FRAMES (320-324)
AREA RECOMMENDED FOR PRESERVATION

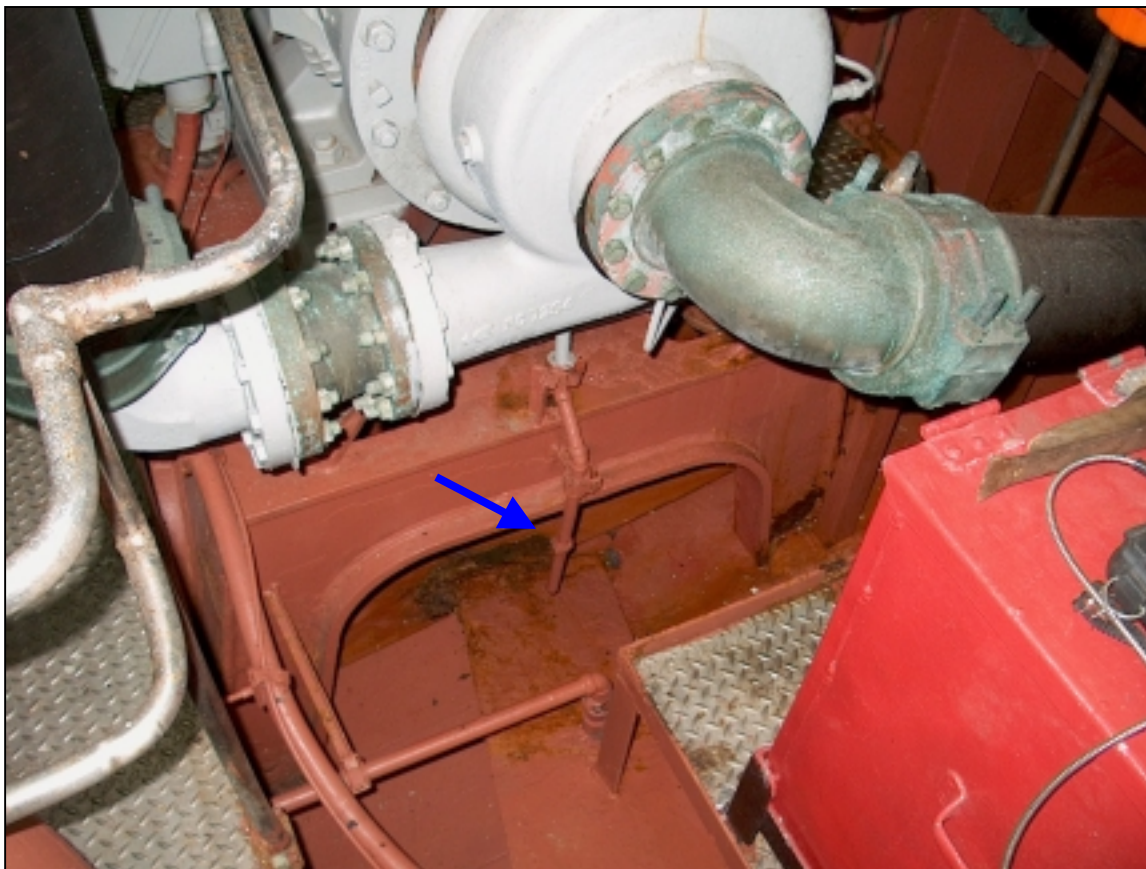
DISCREPANCY DESCRIPTION: PER SEMAT II UNDERWATER HULL ASSESSMENT: STBD SIDE, (5-260-0-E) AUX 2					
TANK TOP UNDERNEATH FIRE PUMP NO.4 HAS SURFACE RUST AND PAINT SEPARATION. DRAIN LINE FROM FIRE PUMP NO.4					
EMPTIES ON TANK TOP CAUSING CORROSION. APPROXIMATELY 6 SF.					
RECOMMENDED REPAIRS: RECOMMEND SHIPS FORCE CLEAN AREA TO BARE METAL PRIME AND PAINT TO MATCH.					
SSPORT C221 POC: B. WILLIAMS (757) 396-4001 EXT 2186, TPOC: M. MELVIN					
CSMP SUMMARY: CORROSION ON TANK TOP UNDER FIRE PUMP NO.4				TEST# MRC 1102/1	
ROOT CAUSE/AMPLIFICATION: H1				STEP# 1,2,3,4 & 5	
SYSTEM LEVEL IMPACT:					
PART NO.	NOMENCLATURE		QTY	NSN	COST
1					
2					
3					
4					
5					
6					
FIRST CONTACT BREKKE	RATE HT1	SECOND CONTACT CARL	RATE HT2	PHONE	
ASSESSOR / ACT / TECH ID# J. LaROCK/ T. ILGENFRITZ QED SYSTEMS INC.			TD	TL	LOGISTICIAN TSP

STBD SIDE, CORROSION ON TANK TOP AND STIFFNER UNDERNEATH
FIRE PUMP NO.4. ARROW INDICATES DRAIN LINE, ROOT CAUSE OF CORROSION.

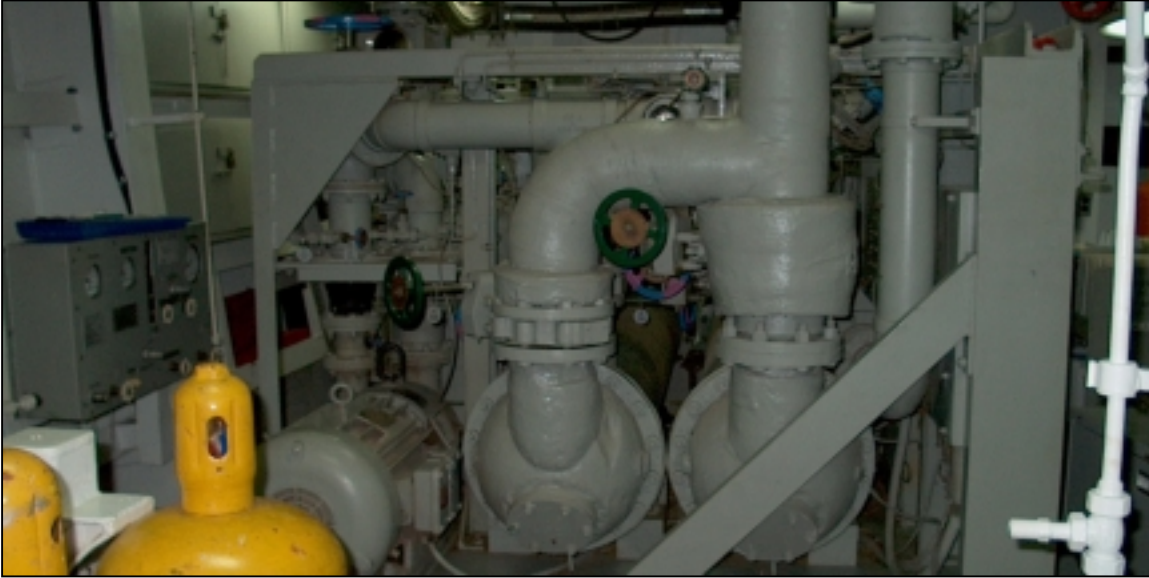
A/C PUMPS 1& 2, U/T READINGS WERE TAKEN ON TANK TOP / DECK SURROUNDING
FOUNDATION AND ACCESS TO F/O TANK (6-220-4-F)
SEE ATTACHED DRAWING

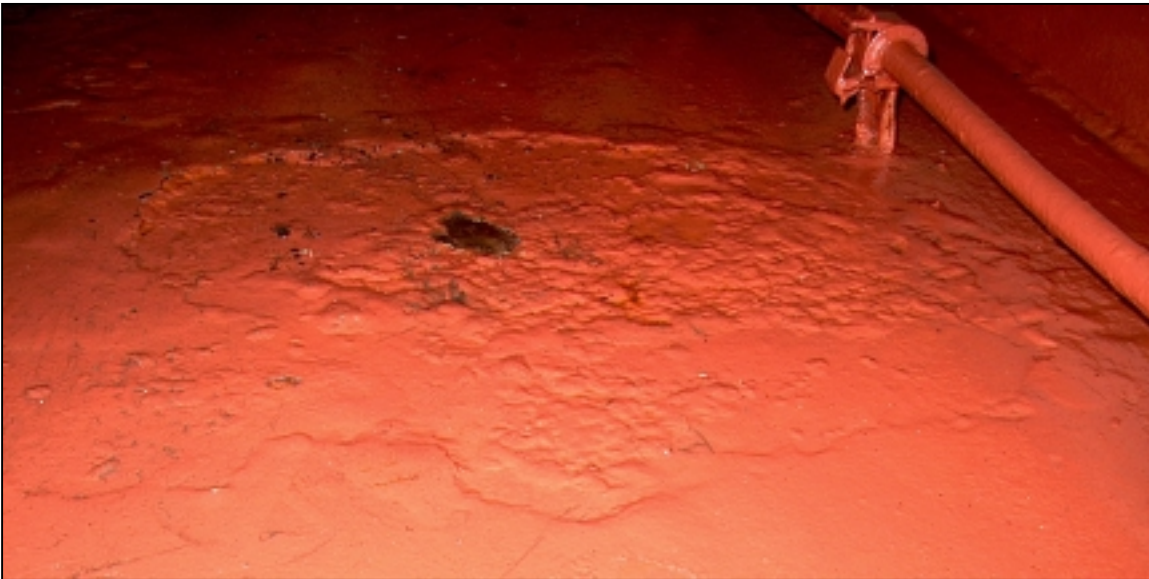
DISCREPANCY DESCRIPTION: PER SEMAT II UNDERWATER HULL ASSESSMENT: PORT SIDE, UPPER LEVEL (5-220-0-E) AUX 1					
U/T SURVEY REVEALED APPROXIMATELY 2 SF OF THIN TANK TOP APPROX 3 FT INBOARD OF PORT SIDE SHELL BETWEEN WEB FRAMES (228-236). HEAVY PAINT SEPARATION SURROUNDS ENTIRE FOUNDATION OF A/C PUMPS 1 & 2, APPROX 100 SF.					
RECOMMENDED REPAIRS: RECOMMEND REPAIR ACTIVITY, CLEAN AND GAS FREE F/O TANK (6-220-4-F) AND REMOVE INTERFERENCES.					
CUT OUT APPROXIMATELY 4 SF OF TANK TOP / DECK, REPLACE WITH .375 MILD STEEL. PERFORM LEAK TEST. CLEAN APPROX 100 SF OF AREA TO BARE METAL PRIME AND PAINT TO MATCH					
SSPORT C221 POC: B. WILLIAMS (757) 396-4001 EXT 2130, TPOC: M. MELVIN					
CSMP SUMMARY: TANK TOP / DECK IS THINNING, HEAVY PAINT SEPARATION AROUND A/C PUMPS 1 & 2				TEST# MRC 1102/1	
ROOT CAUSE/AMPLIFICATION: H1				STEP# 1,2,3,4 & 5	
SYSTEM LEVEL IMPACT:					
PART NO.	NOMENCLATURE		QTY	NSN	COST

TANK TOP / DECK BETWEEN A/C PUMPS 1&2 AND PORT SIDE SHELL
APPROXIMATELY 2 SF OF AREA REVEALED LOW U/T READINGS
NOTE HEAVY BLISTERING OF PAINT

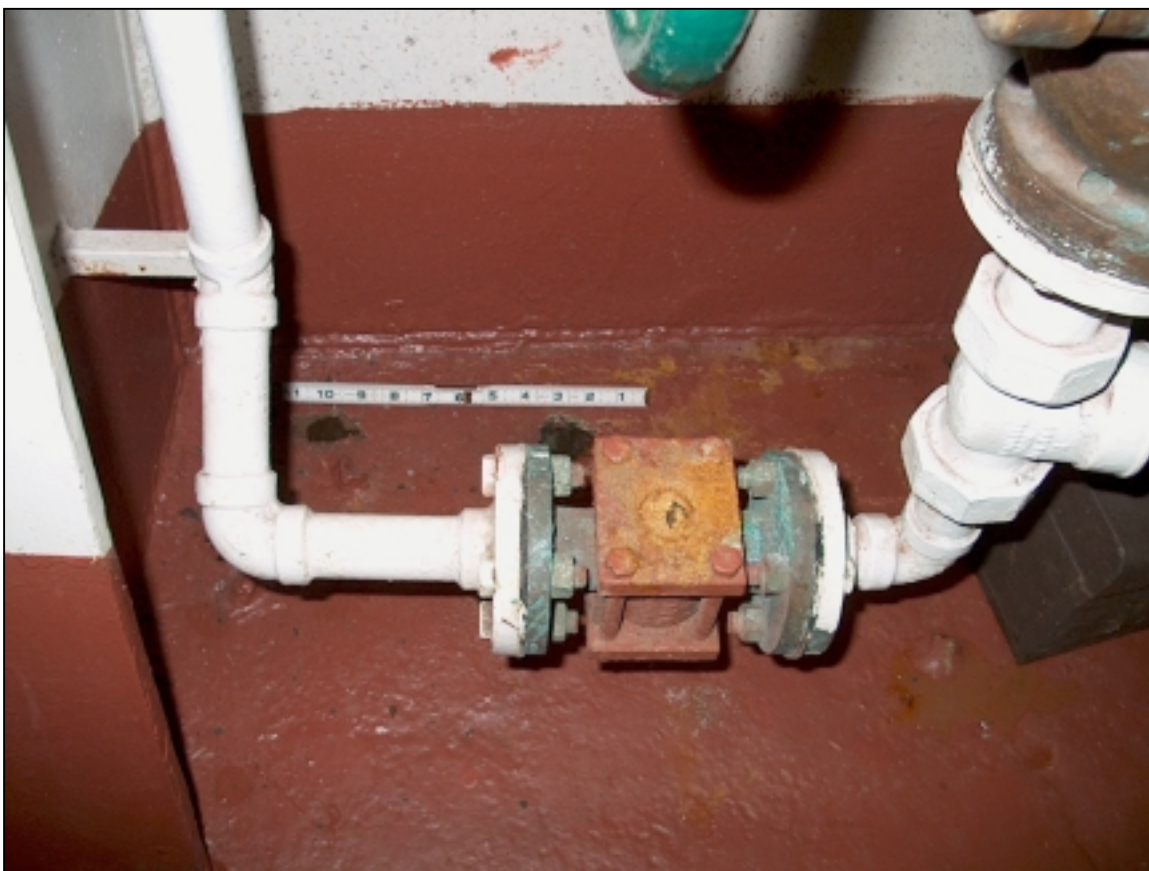
DISCREPANCY DESCRIPTION: PER SEMAT II UNDERWATER HULL ASSESSMENT: STBD SIDE (5-220-0-E) AUX 1 UPPER LEVEL					
TANK TOP / DECK (F/O TANK 6-220-3-F), LOW U/T READINGS WERE REVEALED AT WF(228) AND FWD OF CONVERTER (1STCB)					
POOR BONDING OF PAINT BETWEEN CONVERTER AND SHELL AND INBOARD OF CONVERTER (1STCA). DECK DRAIN FWD OF (1STCA) IS PAINTED OVER PREVENTING PROPER DRAINAGE.					
RECOMMENDED REPAIRS: RECOMMEND REPAIR ACTIVITY CLEAN AND GAS FREE (F/O TANK 6-220-3-F) CUT OUT APPROX 4 SF OF TANK TOP REPLACE WITH .375 MILD STEEL. PERFORM LEAK TEST ON TANK, CLEAN APPROX 150 SF OF AREA TO BARE METAL, PRESERVE AND PAINT TO MATCH					
SSPORT C221 POC: B. WILLIAMS (757) 396-4001 EXT 2130, TPOC: M. MELVIN					
CSMP SUMMARY: TANK TOP IS THINNING, AND HAS HEAVY PAINT FAILURE				TEST# MRC 1102/1	
ROOT CAUSE/AMPLIFICATION: H1				STEP# 1,2,3,4 & 5	
SYSTEM LEVEL IMPACT:					
PART NO.	NOMENCLATURE		QTY	NSN	COST
1

TANK TOP / DECK FWD OF WF (228) UNDER SW. STRAINER VALVE SWS-2299
LOW U/T READINGS WERE FOUND IN THIS AREA SEE DRAWING.

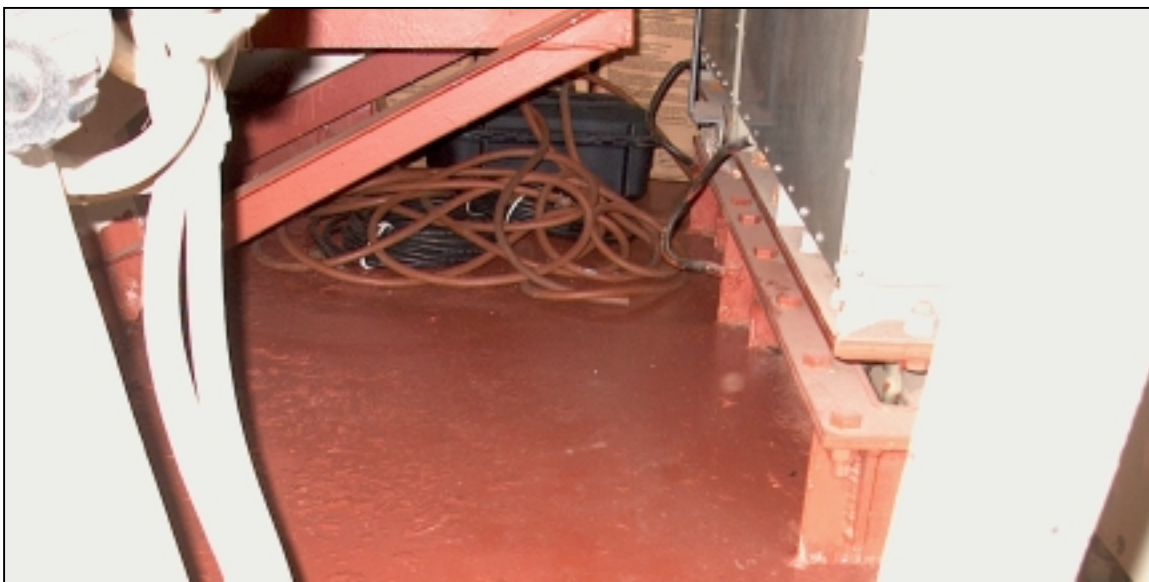
TANK TOP / DECK BETWEEN STBD SHELL AND (60 / 400 HZ CONVERTER 1STCB)
HAS HEAVY PAINT BUILD UP WITH POOR BONDING

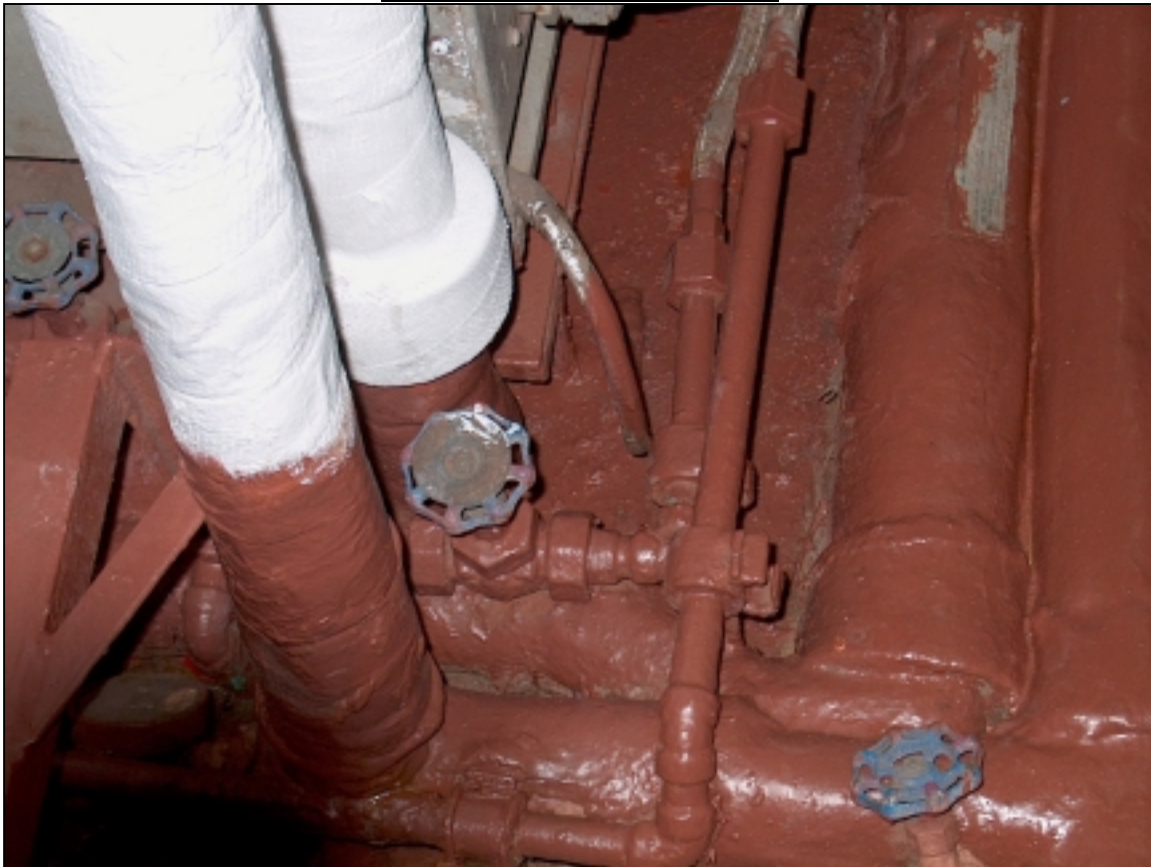
DECK INBOARD OF (60 / 400 HZ CONVERTER 1STCA)
CONCENTRATION OF PIPING PREVENTS SHIP'S FORCE FROM PERFORMING
PROPER MAINTENANCE

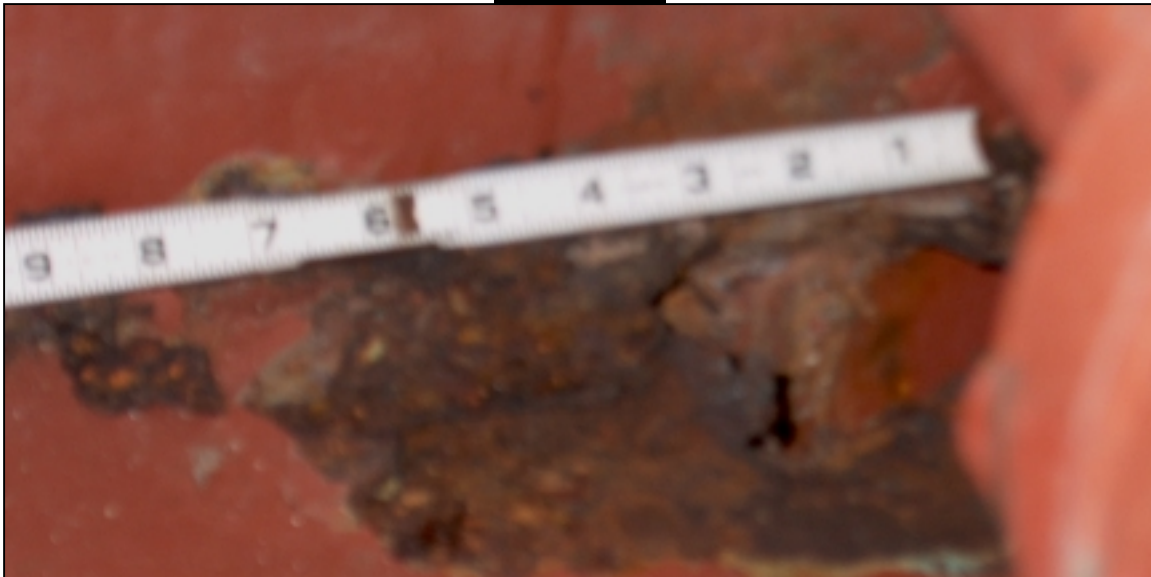
SAFETY HAZARD: 1. SERIOUS - CORRECT AS SOON AS POSSIBLE 2. SERIOUS - SUSPENSION OF EQUIPMENT/SYSTEM/SPACE REQUIRED 3. SERIOUS - WAVIER OF EQUIPMENT/SYSTEM 4. SAFETY ITEM - MINOR 5. COMBUSTIBLE MATERIAL				1. MAINTENANCE ACTION COMPLETED: PARTS DRAWN FROM SUPPLY 2. MAINTENANCE ACTION COMPLETED: REQUIRED PARTS NOT DRAWN FROM SUPPLY 3. MAINTENANCE ACTION COMPLETED: NO PARTS REQUIRED 4. CANCELLED - DEFERRAL WILL BE REMOVED FROM CSMP 5. MAINTENANCE ACTION COMPLETED: 3-M CAPABILITY UTILIZED 6. NONE OF THE ABOVE, DESCRIBE IN REMARKS/DESCRIPTION SECTION				1. MANDATORY 2. ESSENTIAL 3. HIGHLY DESIRABLE 4. DESIRABLE			
DISCREPANCY DESCRIPTION: PER SEMAT II UNDERWATER HULL ASSESSMENT: PORT SIDE, (5-174-0-E) MER 1											
4 TH STRINGER UP FROM MARGIN PLATE IS HOLED APPROXIMATELY 1 FT FWD OF WEB FRAME (204). 2 ND STRINGER UP FROM MARGIN PLATE IS HOLED APPROX 1 FT FWD OF WEB FRAME (204). BILGE POCKET, SHELL AND STRINGERS FROM WF (204-196) APPROX 100 SF HAVE RUST AND HEAVY PAINT SEPARATION. SEE DRAWING FOR U/T READINGS. UNABLE TO ASSESS ENTIRE AREA DUE TO INTERFERENCES.

HOLE IN WEB OF 4TH STRINGER FROM MARGIN PLATE 1 FT FWD OF WEB FRAME (204)

RECOMMENDED REPAIRS: RECOMMEND REPAIR ACTIVITY CUT OUT AND REPLACE APPROX 6 LF OF BOTH STRINGERS (10 X 4 T-BEAM). REMOVE INTERFERENCES, CLEAN ENTIRE AREA TO BARE METAL, PRESERVE AND PAINT TO MATCH. APPROX 100 SF											
SSPORT C221 POC: B. WILLIAMS (757) 396-4001 EXT 2130, TPOC: M. MELVIN											
CSMP SUMMARY: 2 ND AND 4 TH STRINGERS ARE HOLED. 100 SF OF PAINT SEPARATION AND RUST.								TEST# MRC 1102/1			
ROOT CAUSE/AMPLIFICATION: H1								STEP# 1,2,3,4 & 5			
SYSTEM LEVEL IMPACT:											
PART NO.		NOMENCLATURE				QTY		NSN		COST	
1											
2											
3											
4											
5											
6											
FIRST CONTACT BREKKE		RATE HT1		SECOND CONTACT CARL			RATE HT2		PHONE		
ASSESSOR / ACT / TECH ID# J. LaROCK/ T. ILGENFRITZ					QED SYSTEMS INC.		TD		LOGISTICIAN		TSP

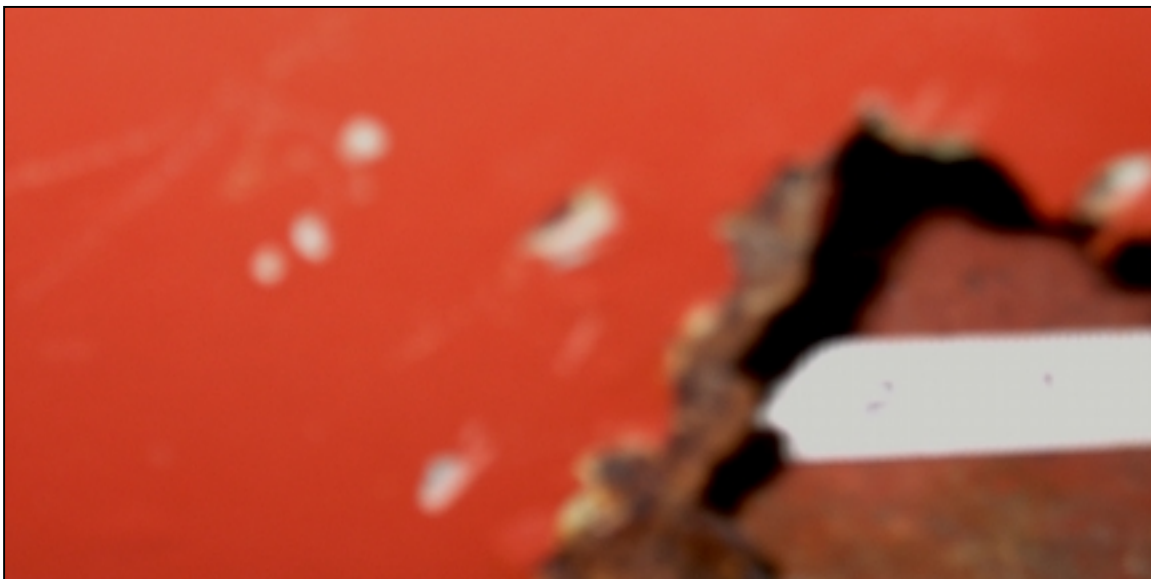
UNDERNEATH VIEW OF HOLE IN STRINGER WEB

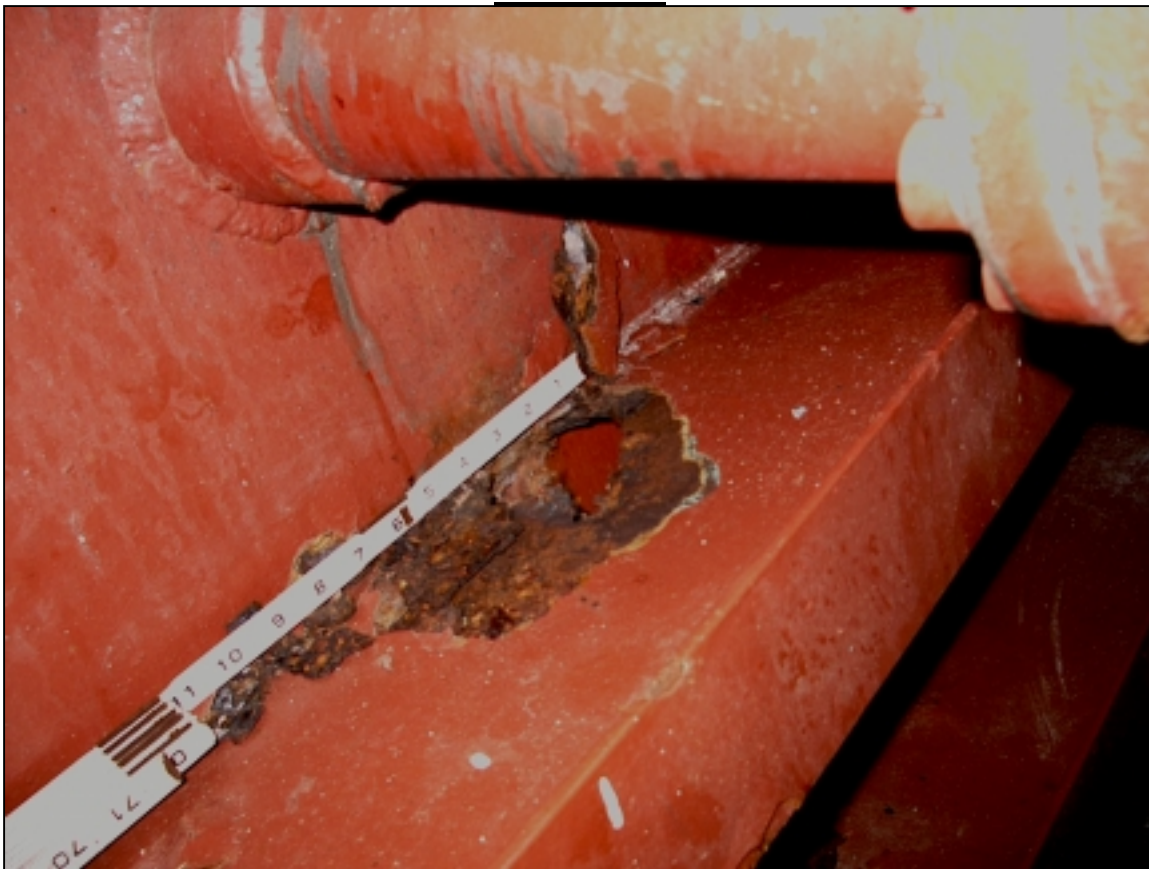
HOLE IN STRINGER WEB 4TH STRINGER UP FROM MARGIN PLATE
REFER TO DRAWING FOR U/T READINGS OF AREA.

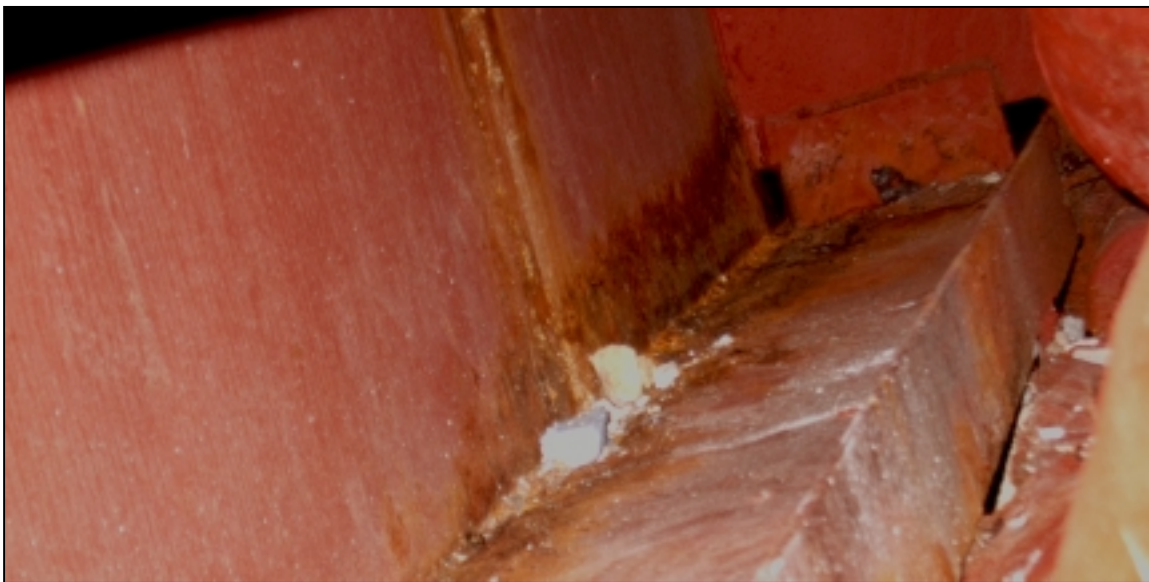
4TH STRINGER UP FROM MARGIN PLATE AT WEB FRAME (196) NOTE
CORROSION. UNABLE TO DO U/T SURVEY DUE TO OBSTRUCTIONS.

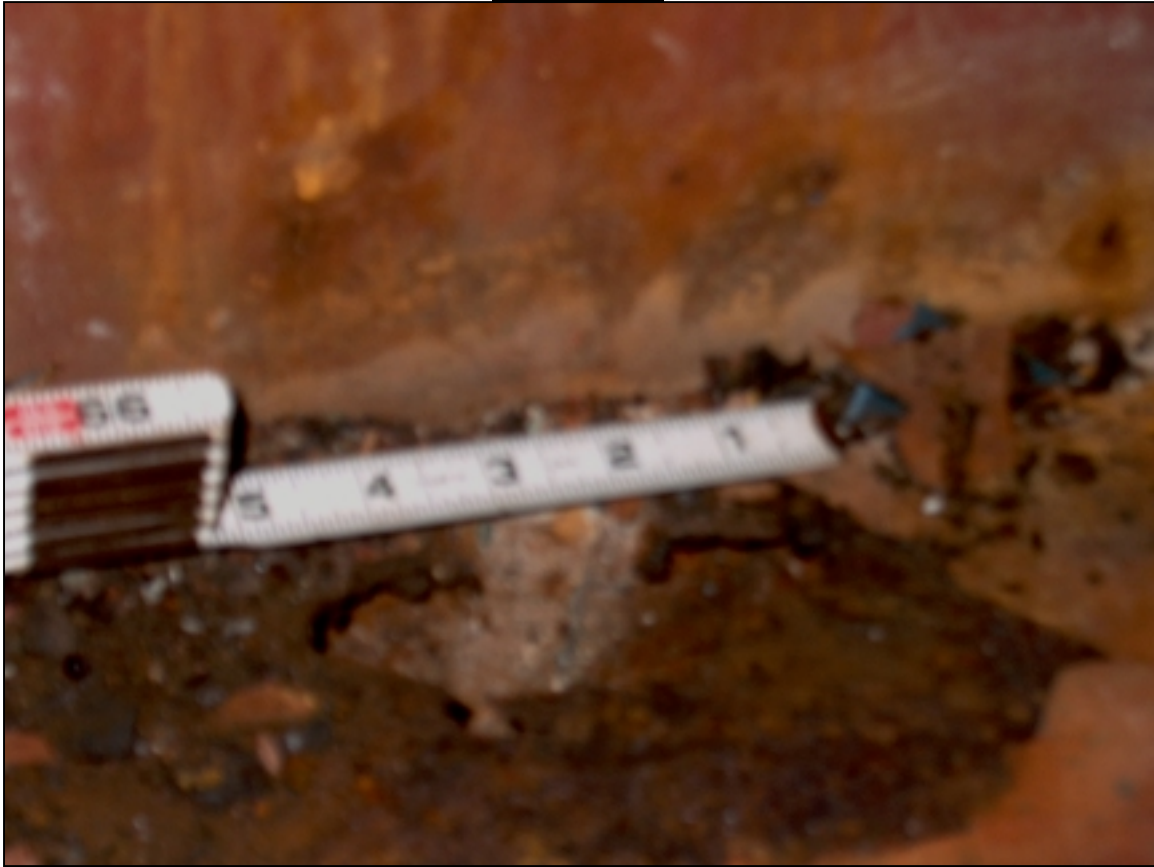
HOLE IN 2ND STRINGER FROM MARGIN PLATE
REFER TO DRAWING FOR U/T READINGS OF AREA.

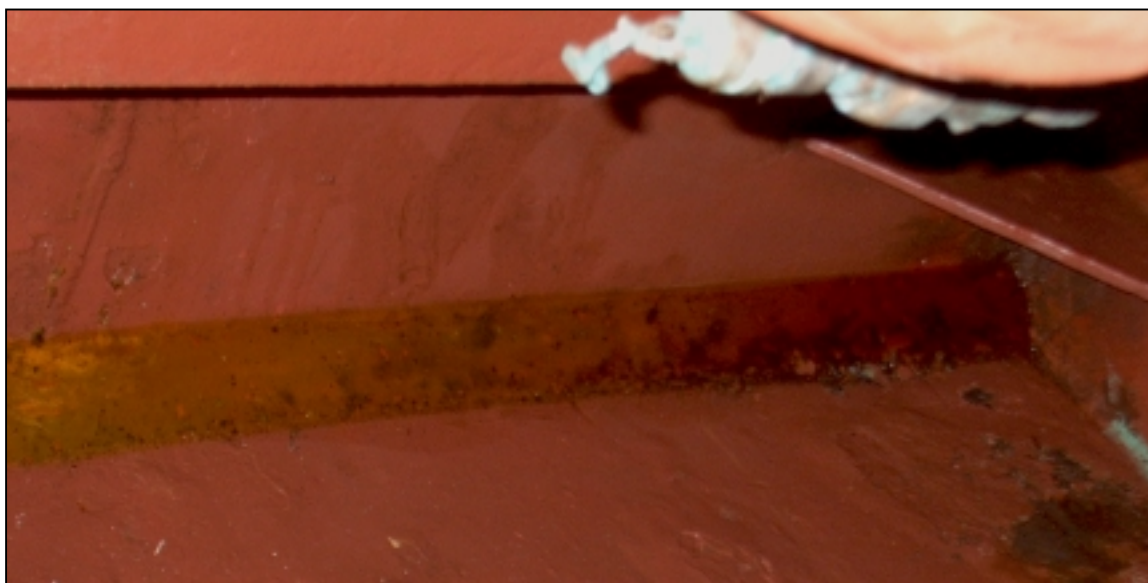
BILGE POCKET FWD OF BHD (220) HEAVY PAINT SCALING WAS DISCOVERED. MINOR THINNING WAS NOTED. SEE DRAWING

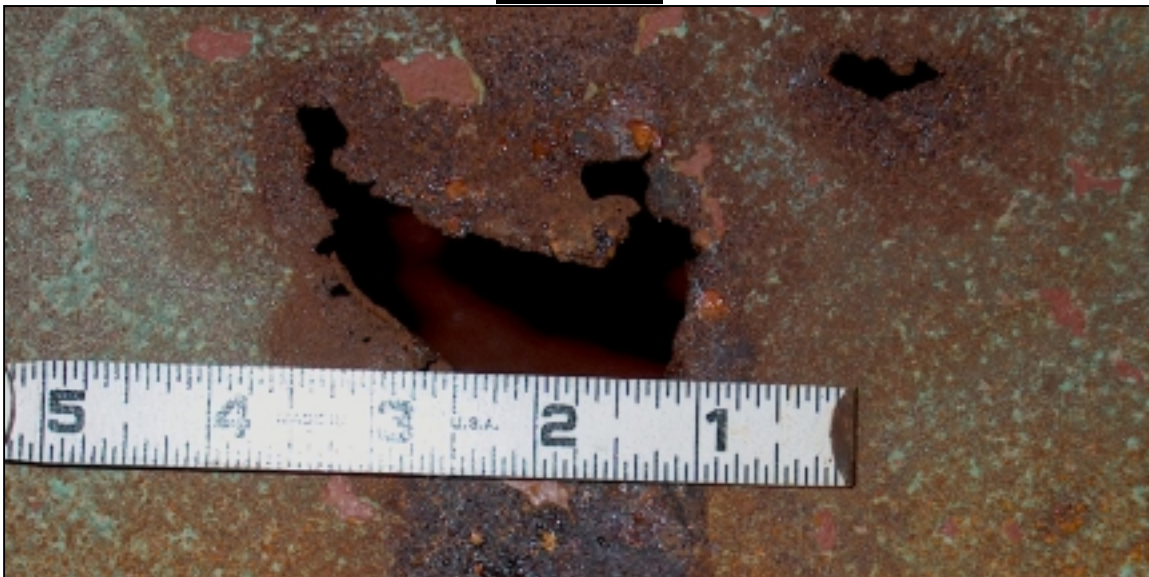
3rd STRINGER UP FROM MARGIN PLATE APPROXIMATELY 1 FT FWD OF
BHD (220), SEE DRAWING FOR U/T READINGS OF SURROUNDING AREA

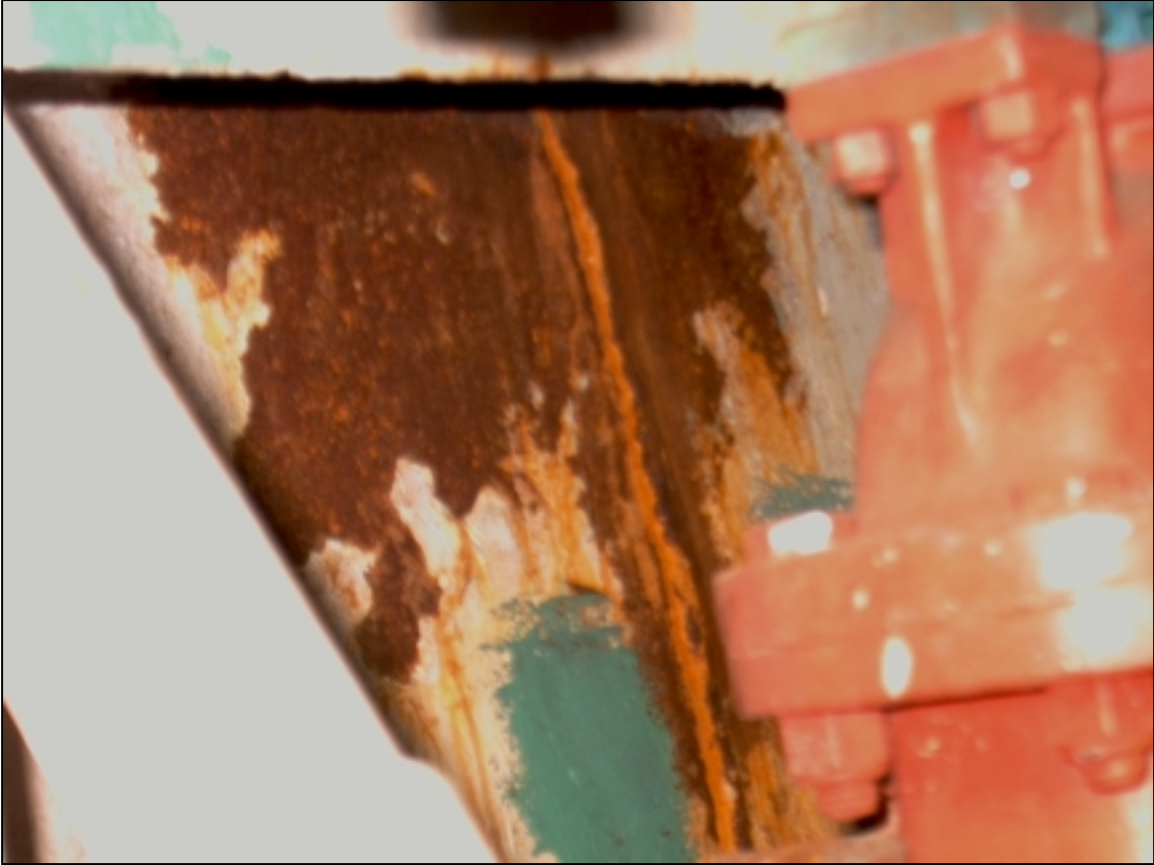
STBD SIDE, FWD OF BHD (220). ENTIRE AREA IS CONSIDERED A "HOT-SPOT" ON
CG-47 CLASS SHIPS

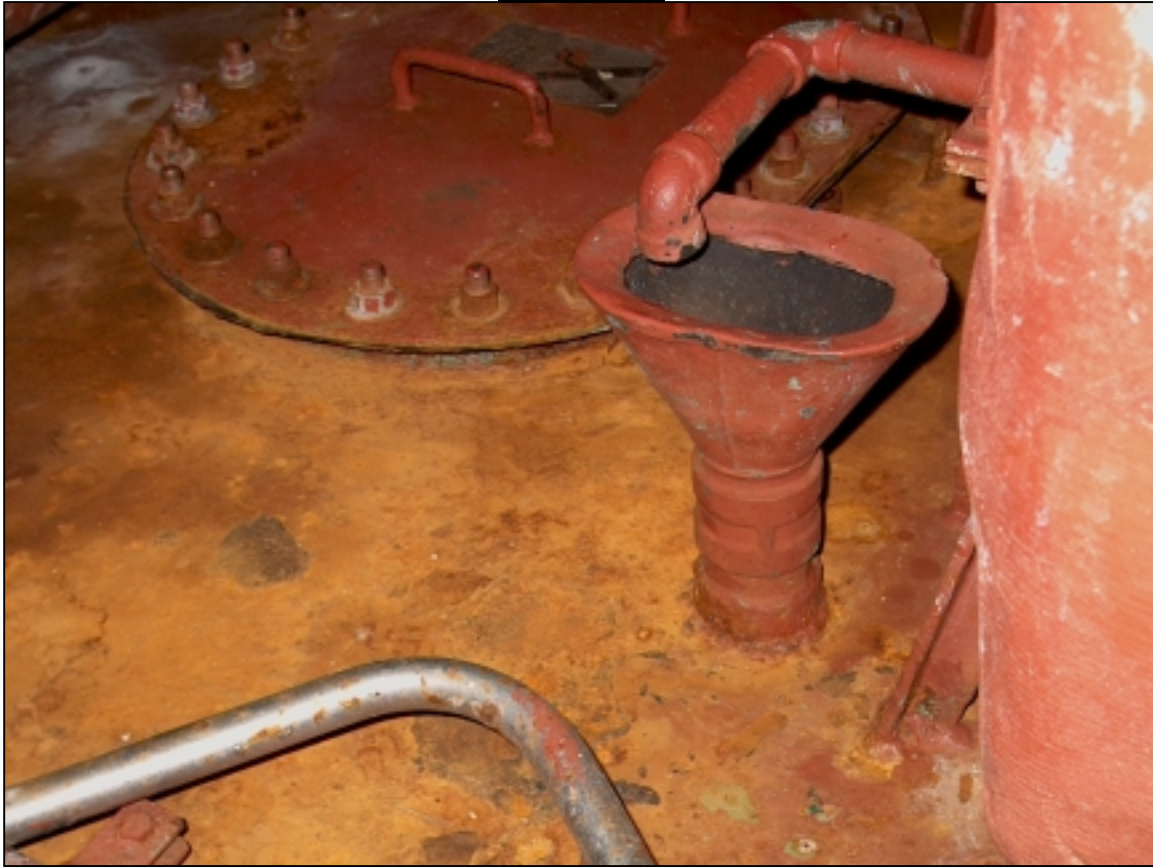
TOP OF FEED WATER TANK (5-216-1-W) PRESERVATION OF THIS AREA IS HIGHLY RECOMMENDED.
